All State Home Inspections LLC

PROPERTY INSPECTION REPORT

Concerning: 1234 Anywhere Ln, Dallas, TX 12245

SEWER SCOPE INSPECTION AGREEMENT & LIMITATIONS

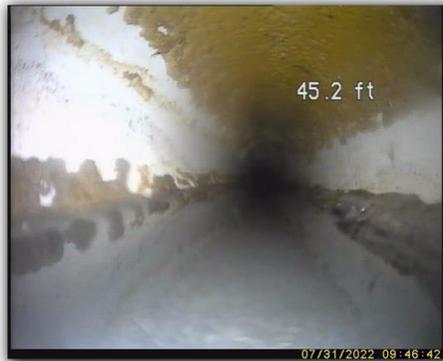
✗ There appears to be a belly in the drain line. A belly in the pipe means there is a low spot holding water. Bellies can accumulate debris and cause clogging of the pipes due to poor drainage.

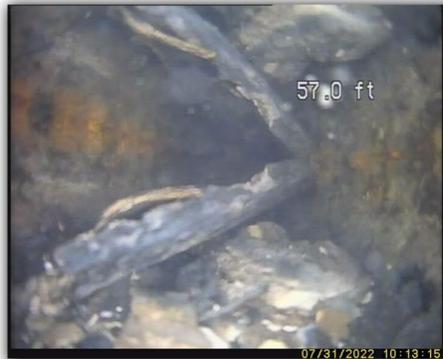
✗ There is an obstruction/blockage in the drain pipe at one or more locations

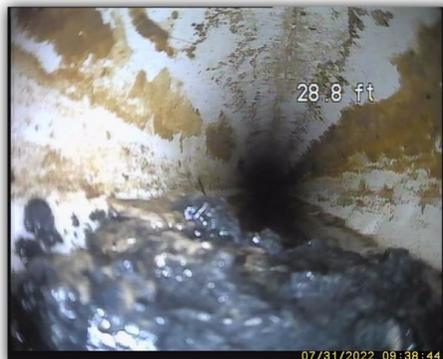
✗ Toilet paper was observed in the drain line at one or more locations. This can be indicative of negative slope or rust/scaling buildup within the pipe. As a result, clogs may develop from time to time.

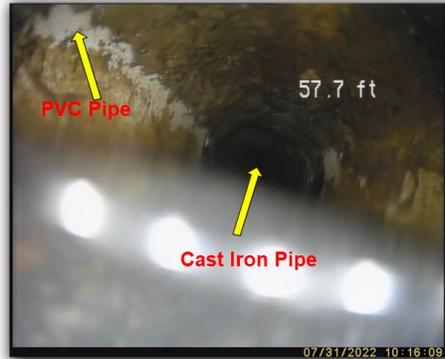
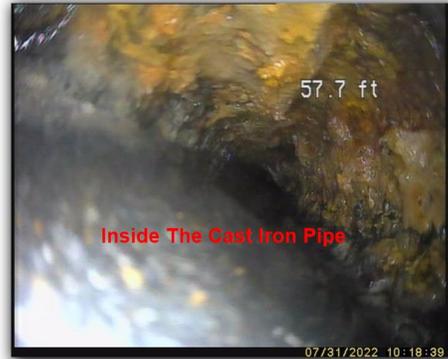
X There appears to be an excessive amount of rust and/or corrosion in the cast iron drains pipes. This could indicate the lines are nearing the end of their life expectancy. The detection of active leaks is beyond the scope of this inspection. Repair or replacement in the near future may be necessary.
